Home Inspection Services, L.L.C.

Home Inspection Report

February 24, 2020

1010 Sample Street
Sample Town, CT

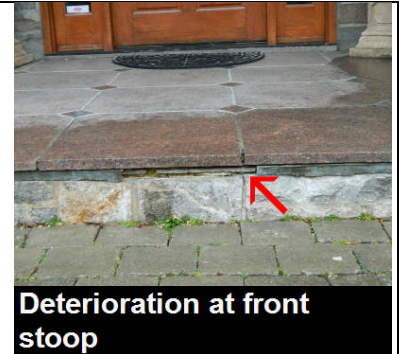
The general condition of the steps and stoops were acceptable at the time of the inspection. Recommend maintaining the steps and stoops as required. ***Note: Missing, loose or deteriorated mortar joints were noted to the steps and/or stoop. Recommend patching or repairing as needed to help avoid further damage.

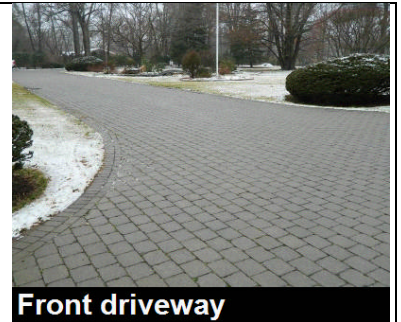
Front driveway

The general condition of the driveway surface and drainage was acceptable.

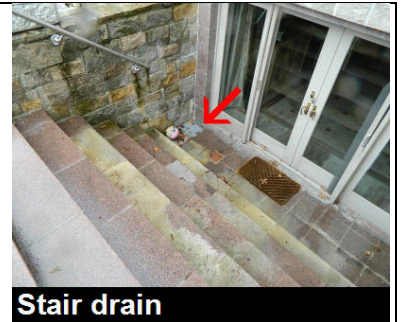
Stair drain

A stairwell drain is present and appears to be in good condition. ***Note: This drain was not flood tested or functionally evaluated during this inspection.

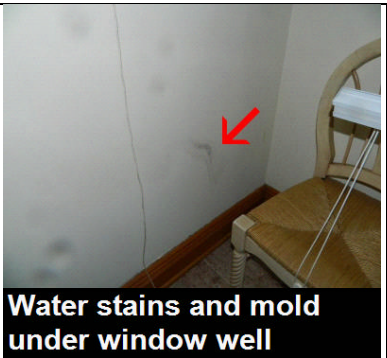
Basement window wells were present. Signs of past present water penetration into the basement area behind the finished walls was present below each of the window wells. Recommend keeping all window wells clean and free of debris to maintain good drainage. By keeping the window wells clean and free of debris you will help to avoid an inviting environment for insects and lessen wood rot or moisture damage by helping to permit the sub-grade levels to be properly ventilated. Further evaluation of the water seepage in and around the window wells by a qualified basement waterproofing contractor is advised prior to closing.

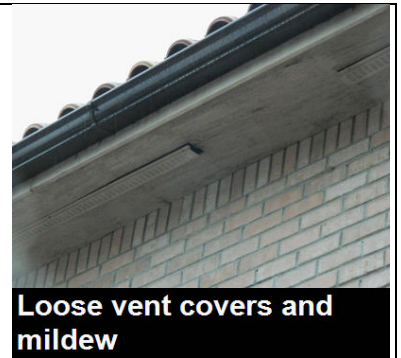
The soffit/eaves were generally in acceptable condition and should be maintained as necessary. Typical wear and tear was present. ***Note: There are some vent screens that are loose or falling out. Recommend properly securing or replacing the venting where needed. ***Note: Mold and/or mildew is present on some surfaces. Recommend power washing, cleaning or treating as needed to remove the mildew and/or mold.

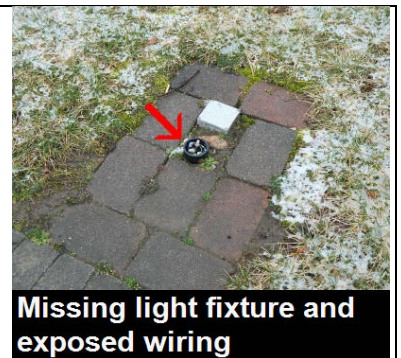
The general condition and operation was acceptable at the time of the inspection. ***Note: A missing exterior light fixture was noted by the front driveway. We recommend repairing or replacing the light fixture or covering the wires as needed for safety.

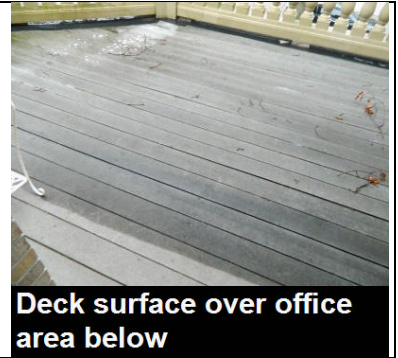
***Note: Unable to fully view the roof covering or material condition due to the wood decking. Signs of a past/present roof leak are present on the ceiling in the office area below the deck. Further evaluation by a roofing contractor is advised, prior to closing.

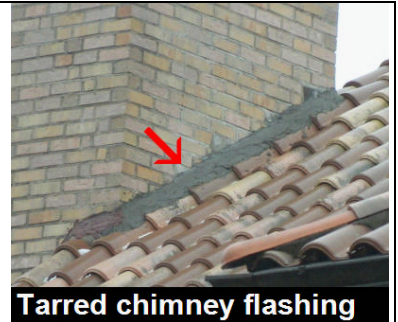
The visible roof flashings appeared to be in acceptable condition. Recommend periodically inspecting and maintaining the roof flashing as required. ***Note: Some of the flashing present has been tarred and is not fully visible. Due to the tar or caulk covering, there is no way to adequately determine the condition of the flashing under the sealant. The usual reason for this excessive sealant on the flashing is to repair or patch a prior leak.

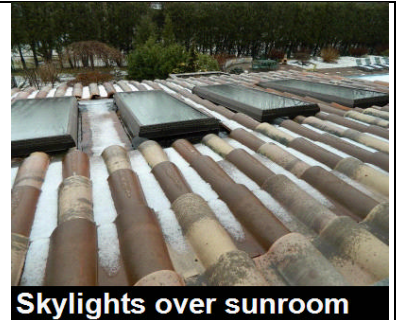
Signs of past/present leaks were noted at the skylights. Moisture stains and water damage was present to the finished surfaces around the skylights. Recommend further evaluation and repair by a licensed roofing contractor. Recommend patching or repairing the damage around the skylights as needed.

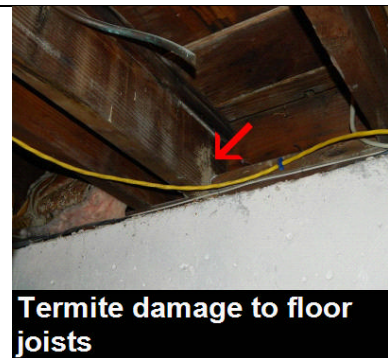
Some wood destroying insect damage was noted to the floor, rim and sill joists over the water heaters in the utility room. ***Note: Some areas of undetected hidden damage may be present. Recommend repairing or replacing the floor joists where needed. ***Note: The majority of the floor joists were finished or obstructed by insulation and not fully visible.

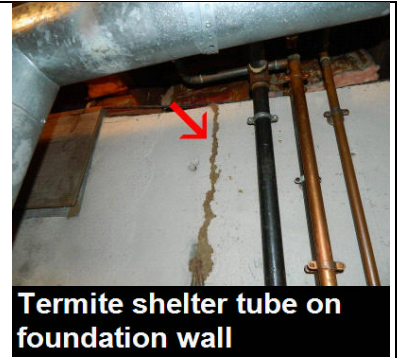
Evidence of active termite infestation was present.
***Note: See the separate termite inspection report and treatment estimate that was provided to you from All County Pest Control at the time of the inspection.

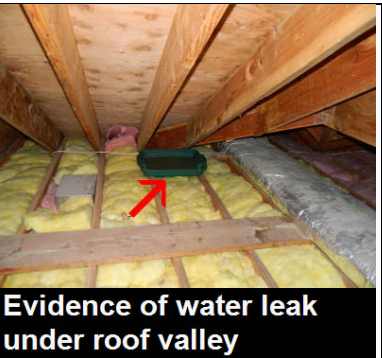
Evidence of past/present water penetration was noted on the sheathing under the roof valley by the center chimney. ***Note: Stains present were tested with a moisture meter and did not appear to be active at the time of the inspection. Recommend inquiring about the history of the stain with the current home owner and monitoring the area during future rain storms.

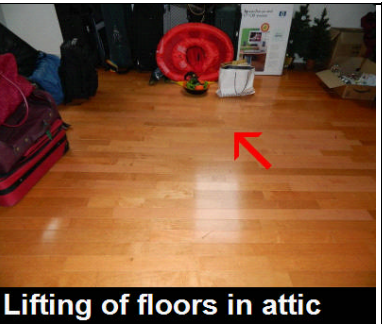
Some buckling and lifting was noted to the finished hardwood floors in the attic. Recommend further evaluation and repair of the floors by a qualified wood floor contractor prior to closing.

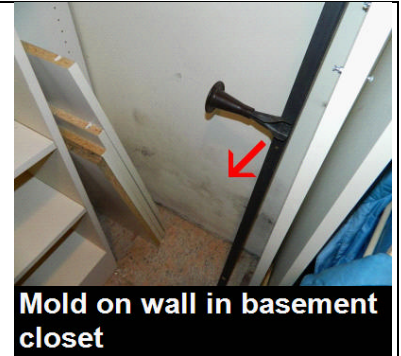
Mold and/or mildew was noted to some finished surfaces in the basement. Signs of suspected mold/fungus growth was noted on the basement walls under and around the exterior basement window wells. This is caused by water penetration, lack of ventilation, high humidity and/or any other type of problem that results in creating moisture. Failure to remedy the source of the moisture can result in continued mold infestation. Prolonged exposures to mold can result in health problems, ranging from mild allergy type symptoms to severe health effects such as respiratory problems. Even though no industry standards exist for this condition at the present time, further evaluation and testing of these areas should to be taken into consideration. We suggest that the mold be physically removed from the home and the areas cleaned using the appropriate controls and precautions of a trained professional. In addition, all associated moisture sources that led to the problem must be corrected. ****Note: This inspection does not include testing for mold types or toxicity. A health hazard may exist from what appears as a simple mold/fungus. Further evaluation and testing by a certified mold inspector is recommended and needed to determine the type and the toxicity levels in the home. ***Note: Testing for airborne mold spores is also excluded from this inspection. Certain molds have been recorded as having various levels of mycotoxins and are known to produce respiratory and neural conditions of various intensities. We recommend consulting with a certified air quality specialist and having air quality testing completed in this home prior to closing.*

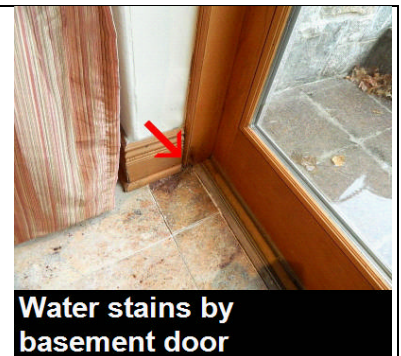
Basement sliding glass door is acceptable and was functional at the time of the inspection. Some signs of past/present water penetration by the door was noted. Recommend cleaning and maintaining the doorway drain system.

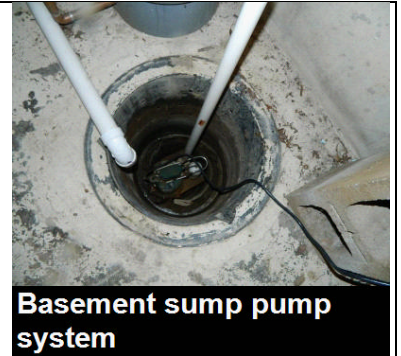
The sump pump was functional and appeared acceptable at the time of the inspection. Sump pumps should be kept in good working order and should be tested several times a year. No safety cover is present over the sump pit. Recommend installing a proper cover for safety.

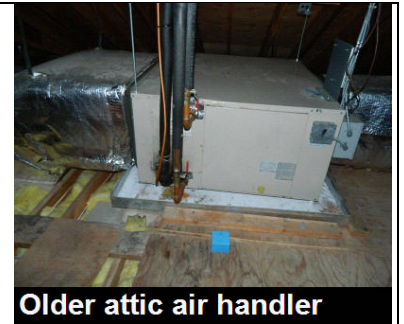
Older attic air handler

***NOTE: The air handler and its associated components are an older units that are at or past the end of their designed life. (Design life typically 20 years +/-). Blower systems lack cleaning and have been neglected. The fan compartments are dirty and in need of a general cleaning and servicing. The lower level and bonus room blower unit in the attic were vibrating and making unusual noises when operating. Recommend further evaluation and repairs by a licensed contractor. Anticipate replacement of these units in the near future.

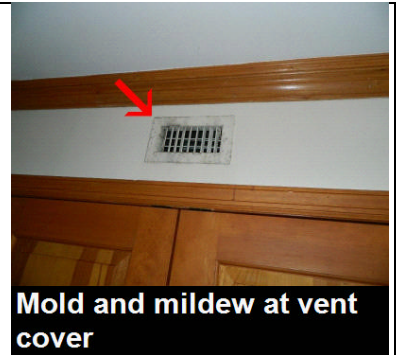
Mold and mildew noted at vent cover in the basement bedroom. ***Note: All forced air systems, including ducts systems should be cleaned as required to help prevent accumulations of dust, dirt and allergenic substances.

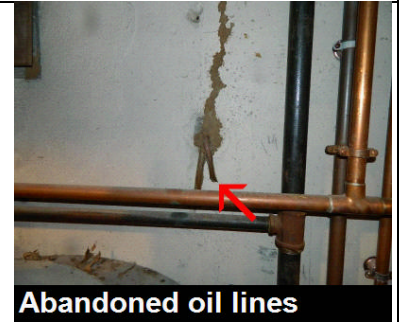
***NOTE: Evidence of an abandoned fuel tank or previously removed fuel tank was noted. Abandoned oil lines were noted in the foundation wall in the basement utility area. Recommend obtaining documentation verifying that the fuel tank was properly abandoned and/or disposed of in compliance with all state and local regulations.

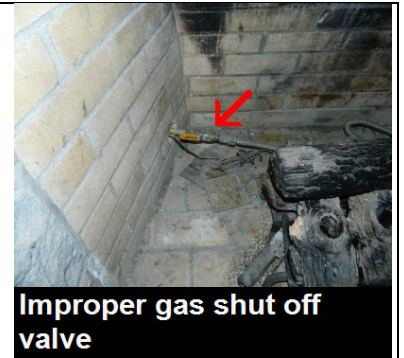
The firebox appears to be sound and useable in its current condition. ***Note: A gas shutoff valve is found inside the basement fire box. This type of installation is not recommended. The valve should be removed to a proper location.

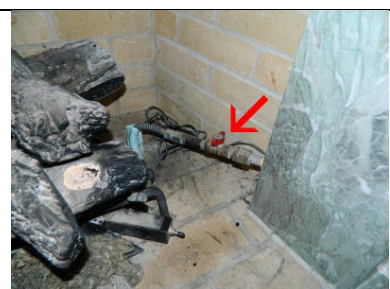
Gas shutoff valve inside firebox

The firebox appears to be sound and useable in its current condition. ***Note: A gas shutoff valve is found inside the living room fire box. This type of installation is not recommended. The valve should be removed to a proper location.

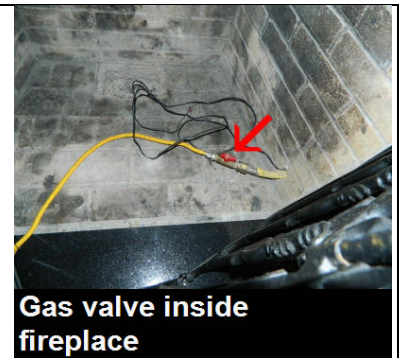
The firebox appears to be sound and useable in its current condition. ***Note: Recommend obtaining a current permit for the installation of the free standing stove from the local fire Marshall. The free standing stove present was not functionally evaluated. ***Note: A gas shutoff valve is found inside the family room fire box. This type of installation is not recommended. The valve should be removed to a proper location.
