Home Inspection Services, L.L.C.

Home Inspection Report

February 24, 2020

1010 Sample Street
Sample Town, CT

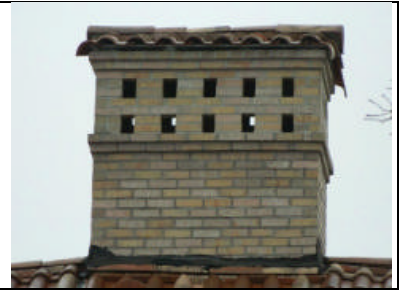
CHIMNEY CONDITION:

The general condition of the chimney was acceptable where visible. Recommend maintaining the chimney structure as required.

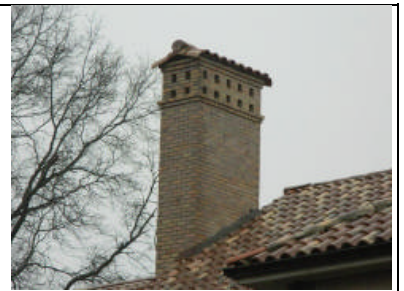
CHIMNEY CONDITION:

The general condition of the chimney was acceptable where visible. Recommend maintaining the chimney structure as required.

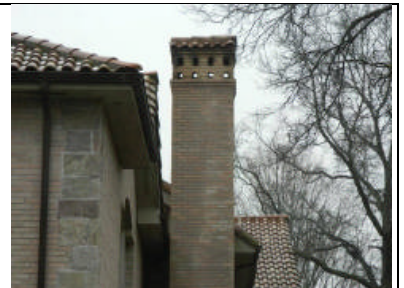
CHIMNEY CONDITION:

The general condition of the chimney was acceptable where visible. Recommend maintaining the chimney structure as required.

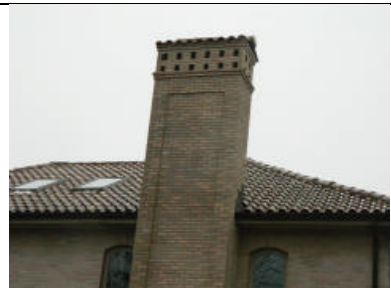
CHIMNEY CONDITION:

The general condition of the chimney was acceptable where visible. Recommend maintaining the chimney structure as required.

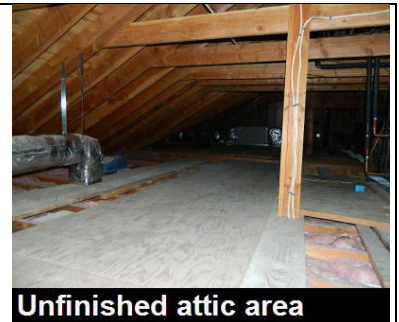
**ACCESSIBILITY AND
CONDITION:**

Entered. Viewing was limited due to flooring, finished surfaces, insulation & limited access.

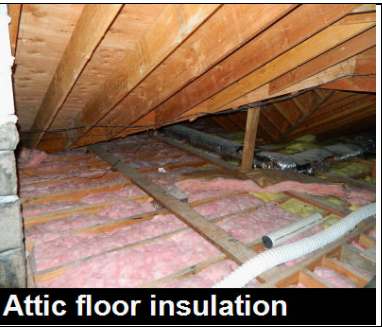
Fiberglass insulation installed between the floor joists. The general condition of the attic insulation appears acceptable where visible. Areas of the attic insulation were finished and were not fully visible. ***Note: We are unable to determine if this insulation is present in all floors, rafters or wall cavities.

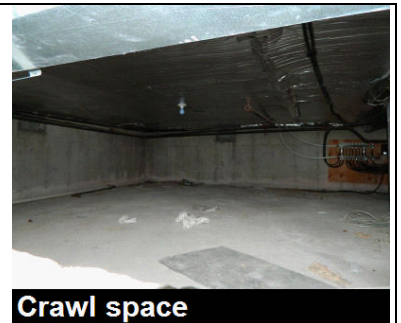
CRAWL SPACE: ACCESSIBILITY:

Viewed crawl space from access only. Viewing was obstructed by under floor insulation.

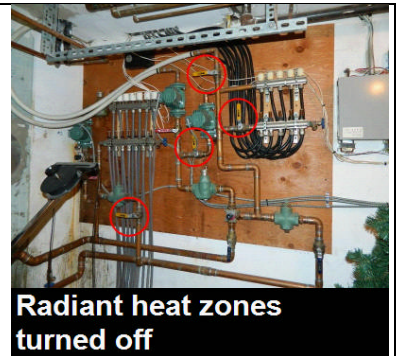
The radiant floor heat zones were turned off at the time of the inspection and could not be functionally evaluated by us at the time of the inspection. A licensed heating contractor should be called in to further evaluate and verify that these radiant floor zones do not leak and function as intended prior to closing. The overall condition of the air duct heat distribution in the home appeared acceptable at the time of the inspection. ***Note: *Only a representative sampling of the heating distribution system is functionally tested on each level during the inspection. Because of individual preferences we do not render an opinion on the heat supply adequacy or the heat distribution balance in each room.*

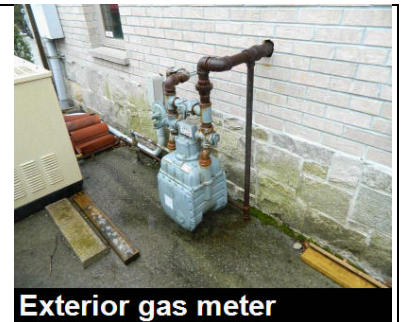
Gas meter and main gas shut off valve is located at the exterior of the building. The general condition of the gas meter was acceptable where visible.

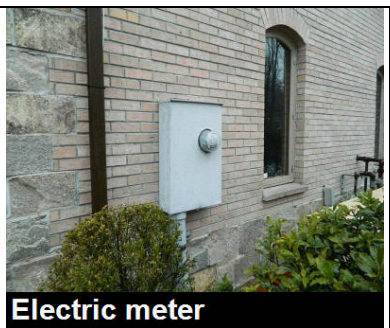
Electric meter

An underground electric service lateral is present. Service lines were functional but not visible.

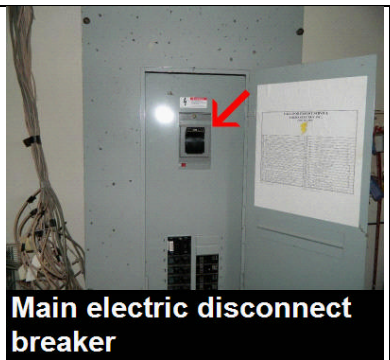
Main electric disconnect
breaker

Breaker. Located inside the main panel.

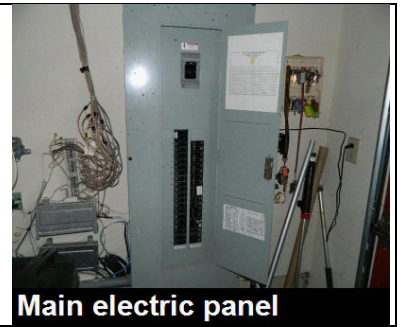
Condition of the main service panel appeared acceptable where visible.

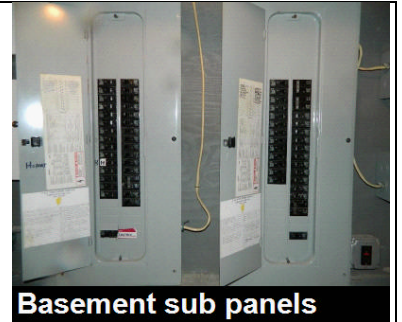
DISTRIBUTION PANEL #1:

Breakers. Located in the basement.

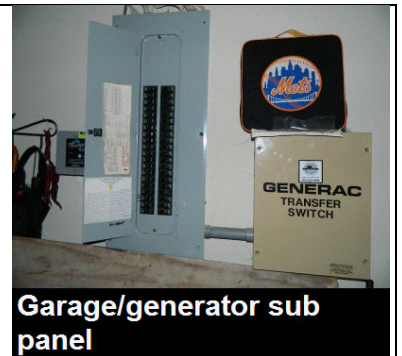
DISTRIBUTION PANEL #2:

Breakers. Located in the garage.

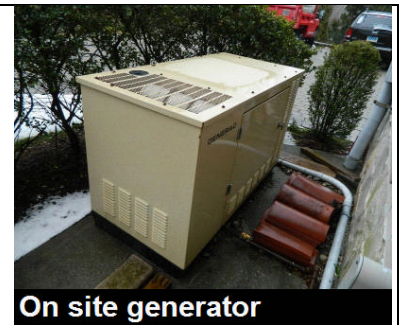
On site generator

***NOTE: Auxiliary generator equipment is present on site. This equipment was not tested or inspected by us and is only listed in the report as being present. The generator equipment is beyond the scope of this home inspection. We recommend that you verify the operation and review the maintenance records for the generator equipment with the current homeowners or a qualified specialist, prior to closing. ***NOTE: A security system is present. The security system was not operated or inspected by us. The system is beyond the scope of this home inspection. We recommend that you inquire about and verify the operation of the system with the current owners or with a qualified alarm specialist prior to closing.

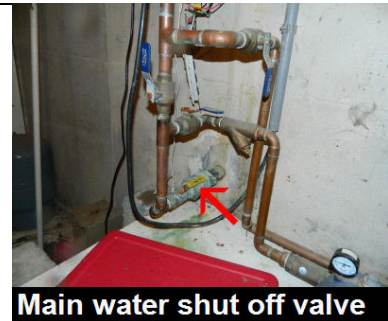
The main water shutoff valve is located in the basement utility area. The main water service line was generally in acceptable condition where readily visible. You should operate the main water valve at least annually to help prevent the valve from freezing in the open position. ****Note: The water service line that connects the house to the main water supply can not be inspected by us and therefore we make no claim to the pipes condition in this inspection report.*

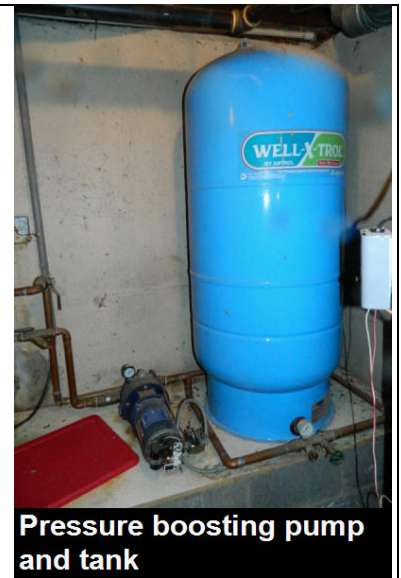
The pressure boosting equipment that is present appears to be used for irrigation purposes only and was turned off at the time of the inspection. The system was not functionally evaluated or inspected by us and is not reflected in this report. We recommend verifying proper operation of the entire system and further evaluation by a licensed contractor as needed.
